Case Study: Increasing Lifetime of Guide Plates for Drawhook

Increase wear life of draw-hook guide plates.

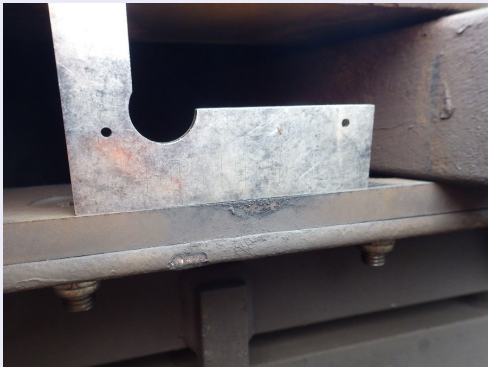
after 50,000 km

RAILKO NF21

stay in top condition
continue to perform

The wear on each liner was recorded after a distance of 50,000 km and 90,000 km. This represents 7 months of dynamic wear.

- Conclusions:
- ✓ RAILKO NF21 guide plates show minimal wear after 90,000 km

✓ Surface of RAILKO NF21 plates remains in good condition across 90,000 km

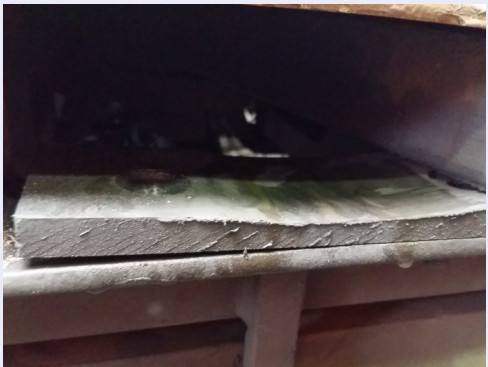
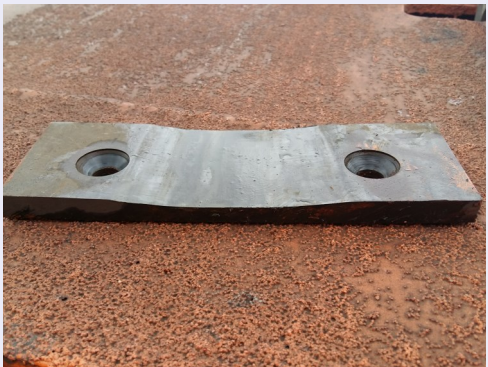
Thermoplastic
Competitor "F"

extremely damaged
must be replaced

Above photos "thermoplastic competitor F" display typical results using thermoplastic plates from a similar TXL test, where after a specific point the plates rapidly deteriorated and suffered severe damage (as shown in photos)

Thermoplastic guide plates suffer extreme wear after only 3 months of use.
