Case Study

Ferobide B.C.Wilson Spreader vane

Gustrower GDK 6000K spreader

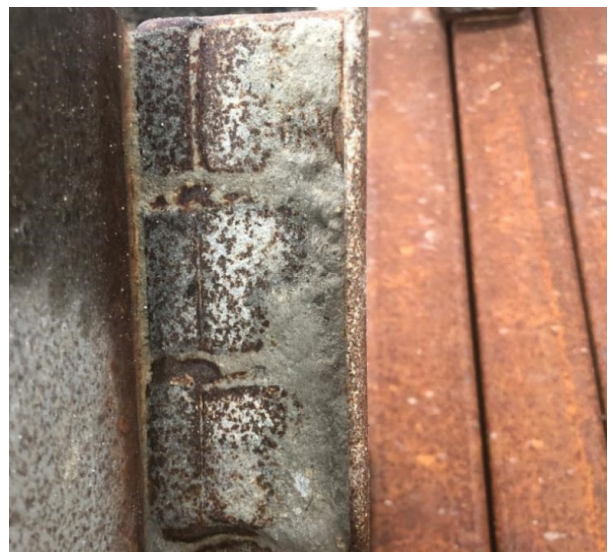
Ferobide tiles were welded onto the spreader vanes in rows. The same Ferobide tiles have survived 10,000 tonnes of lime and 300 tonnes of slag. The benefit is increased uptime and reduce costs. The below photo shows the internal vane after one year.

Ferobide wear tiles welded to vanes

Ferobide has provided an life increase of 2-4 times over hardfacing. This equates to the original Ferobide tiles processing more than 10,000 tonnes of lime and 300 tonnes of steelwork slag, and still working.
