— Case Study: Ferobide wear protection for subsoilers / rippers —

**Technical Challenge**

Increase the life of the legs with a weldable material suitable for repair on the farm.

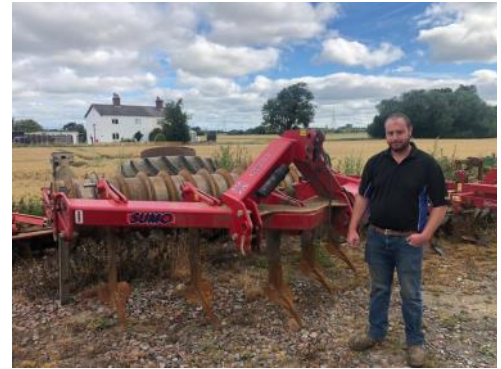
*"Ferobide was applied to the legs three years ago and is still as good as the day it was fitted."*  
Peter Cookson, MH Poskitts.

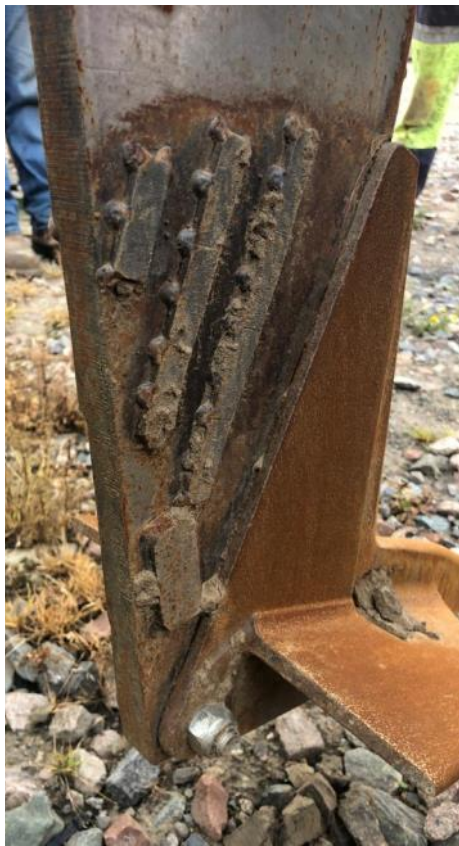
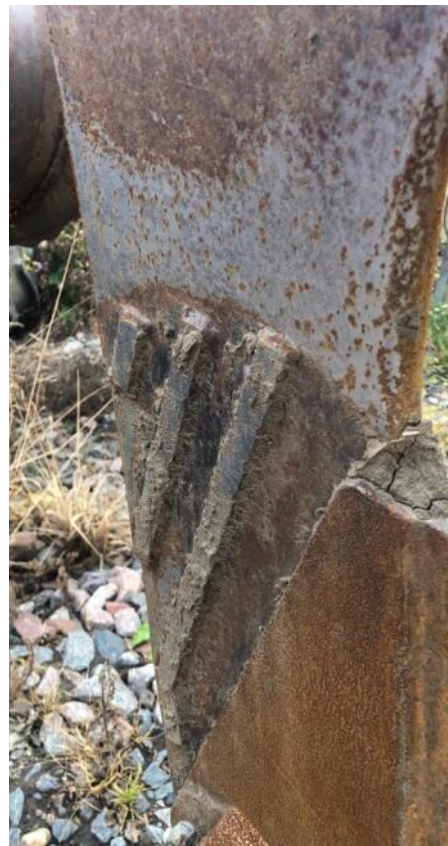
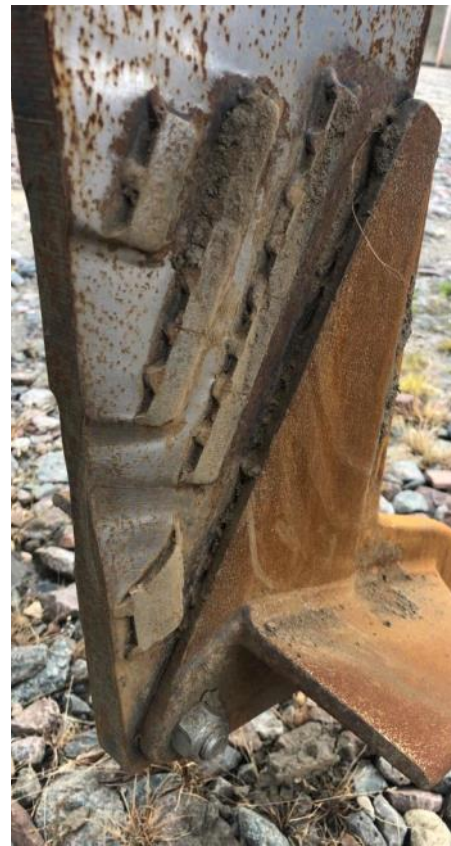
Ferobide tiles applied to the legs have effectively prevented wearing of the base metal **during 3 years and counting** with no additional maintenance required.

Since welding Ferobide to the legs they have not needed to do any refurbishment work, and the Ferobide is currently on its third year running. This has meant significant savings on wearing metal cost and maintenance time.
